CEDIM Forensic Disaster Analysis Group (FDA)
High water/flooding Southern Germany May/June 2016

20 June 2016

1 Introduction

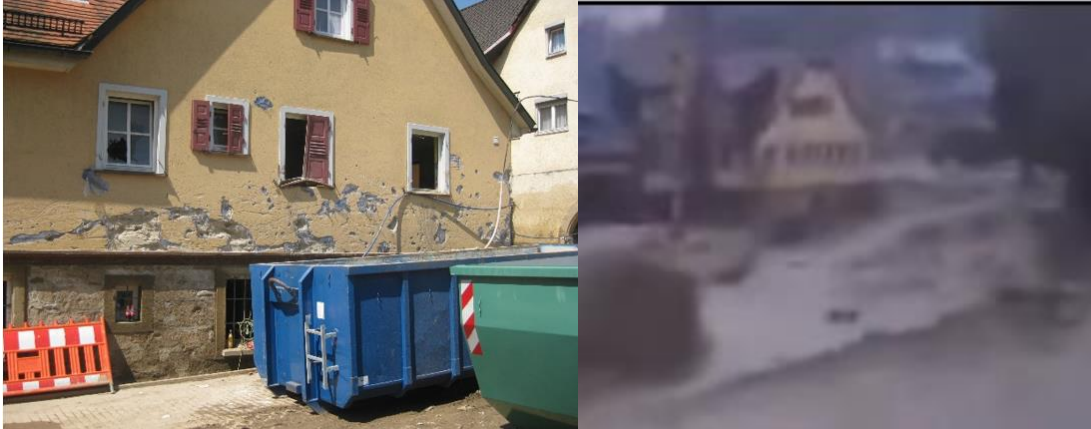
Figure 11: Damage at the Ground Floor (Souterrain/Deep parterre) and First Floor (left); Flow Situation during the Event with Locally Strong Varying Water Levels (right).

The heavy precipitation has led to a large occurrence of debris from the catchment basin of the Orlacher Bach (branches, uprooted tree trunks). These have been building up in front of a bridge passage initially and were then rinsed by the inflowing water masses in the direction of the site. The steep slope caused locally very high flow rates and thus great damage to roads and buildings. After viewing various video recordings, the flow rate of the Kocher at the end of the Orlacher Straße was estimated to more than 7 m/s. The ground floor level of many houses was directly affected; locally the water levels reached the upper floors. To some extent even roofs were damaged by entrained tree trunks and their branches.

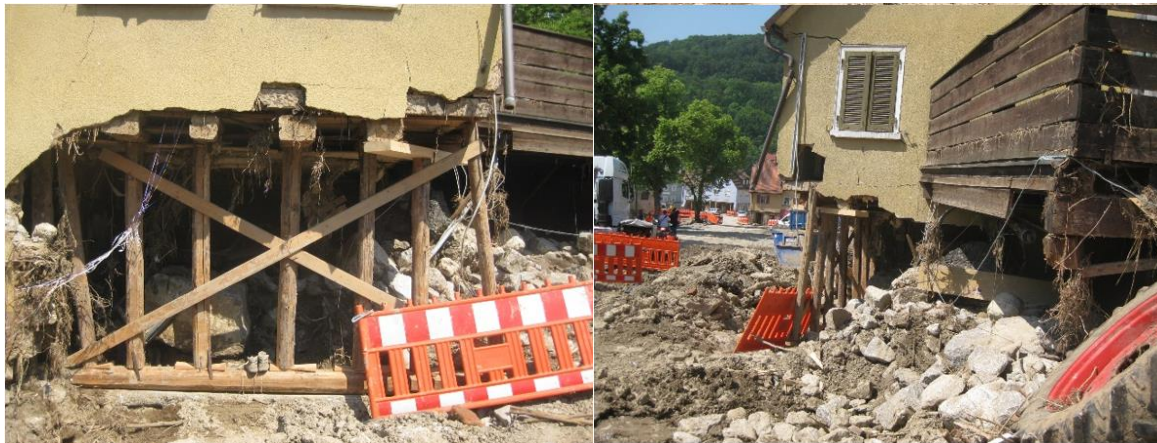
Figure 12: Structural damage to buildings in Braunsbach.

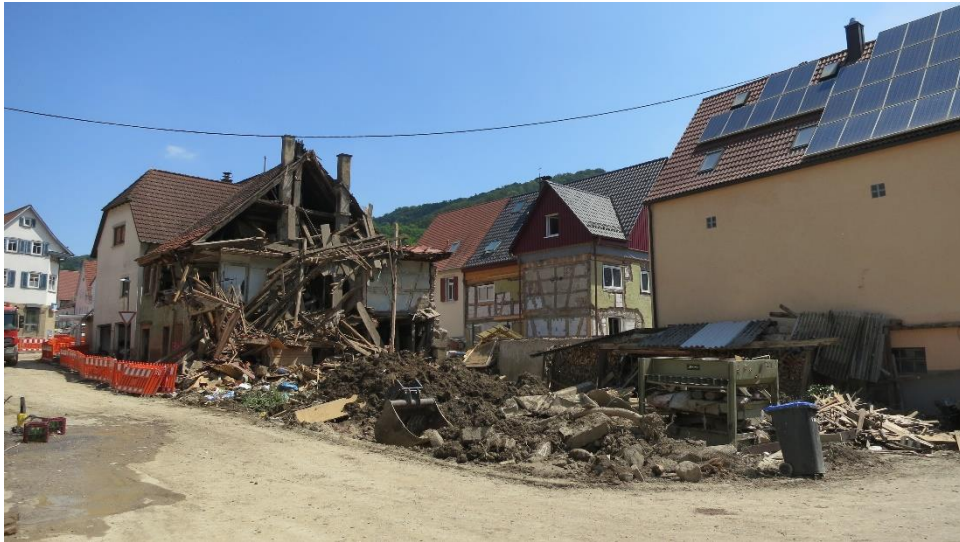
According to eyewitnesses, the maximum water levels were reached within 15 minutes; a similar event had not happened before. A local resident stated that his mother had lived in the town for 92 years and had never before experienced such a big flooding of the Orlacher Bach. In the past, mostly floods of the Kocher have resulted in the flooding of the town.

Figure 13: Buildings destroyed by flow attack and debris impact in Braunsbach.

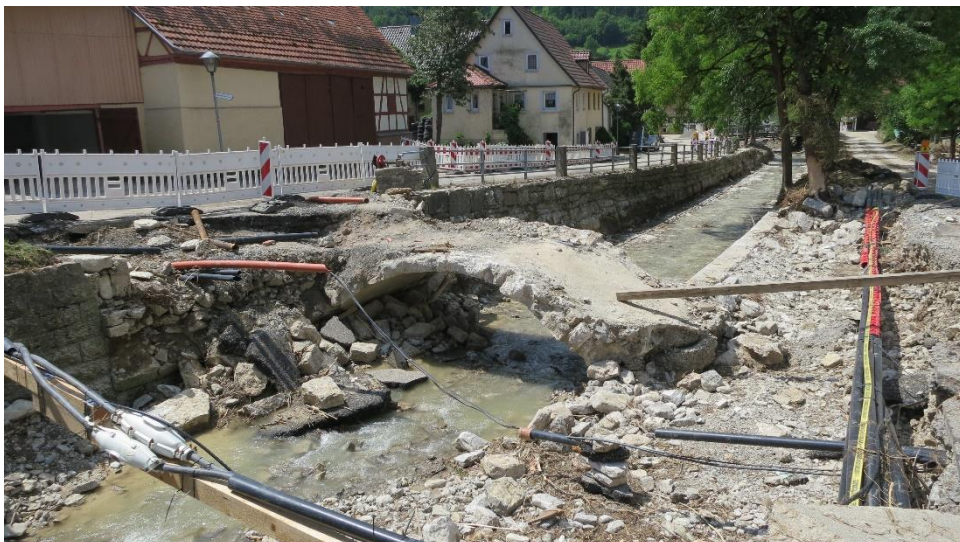
A comparable field characteristic (elongated catchment basin with steep valley flanks) features the Reichenbach, which is located in direct neighborhood and caused damage in the town of Steinkirchen. Here, parts of the infrastructure were affected, which were partly destroyed by local load peaks. Structural damage to buildings did not occur in Steinkirchen.

Figure 14: Damage to streets after a flow-around at a bridge in Steinkirchen.

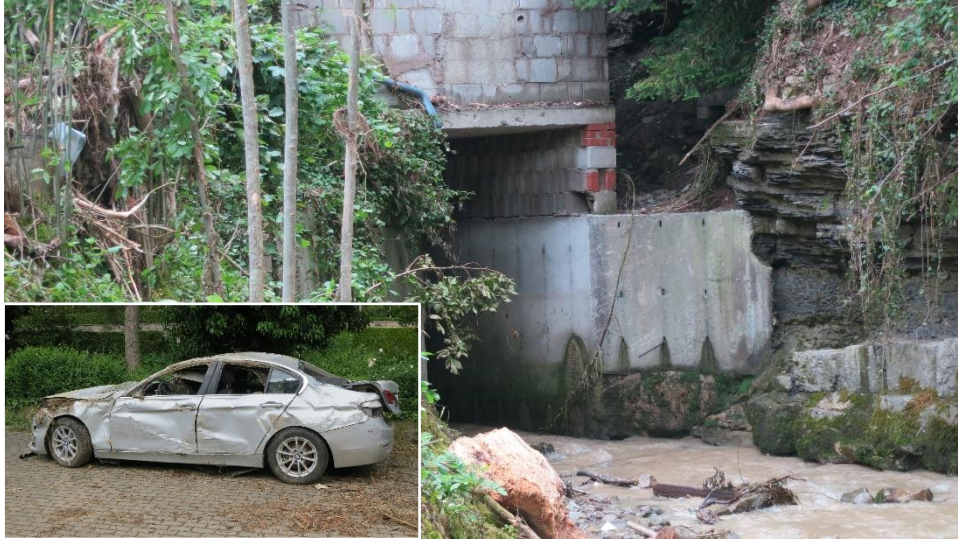
Künzelsau and Forchtenberg. Similar damage patterns were seen in Niedernhall and Künzelsau. Cause of the damages was the overloading of the discharge capacity of the Künsbach, which, partly drained, runs through the city of Künzelsau. Because of debris from the upper catchment area and „inner-city“-debris in the form of motor vehicles respectively, several passages were blocked in urban areas and have led to an overflowing. Many cellars were filled to around 2-2.4m height, and the average sheet flow was around the 30cm mark on the ground floor, causing damage to electrical fittings, heatings, floors and the walls in ground floors and cellars.

Figure 17: Entry to an underpass of a building, which was blocked by a motor vehicle during the High Water.

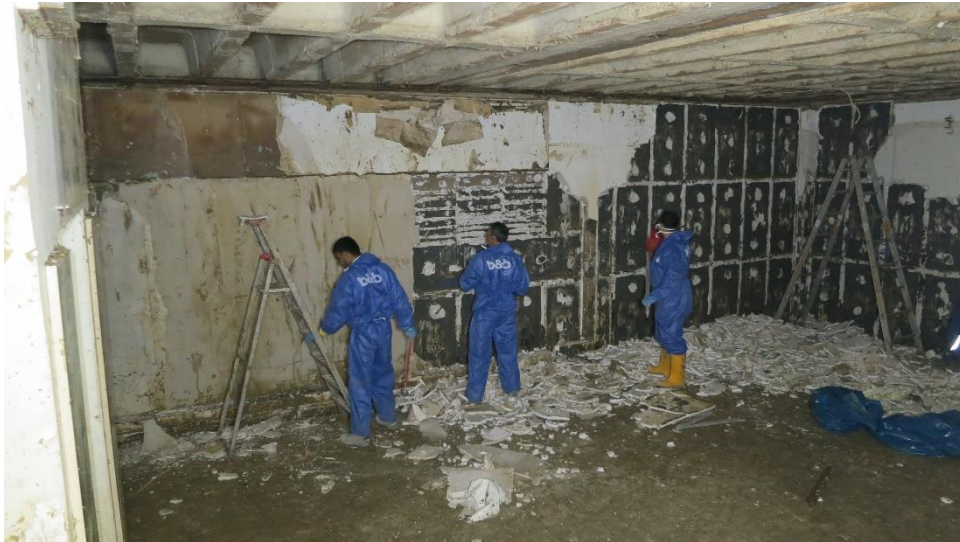
Figure 18: Remediation work at a building in Künzelsau. Because of the moisture damage a dismantling of the basement and ground floors to shell construction status is required in many cases.

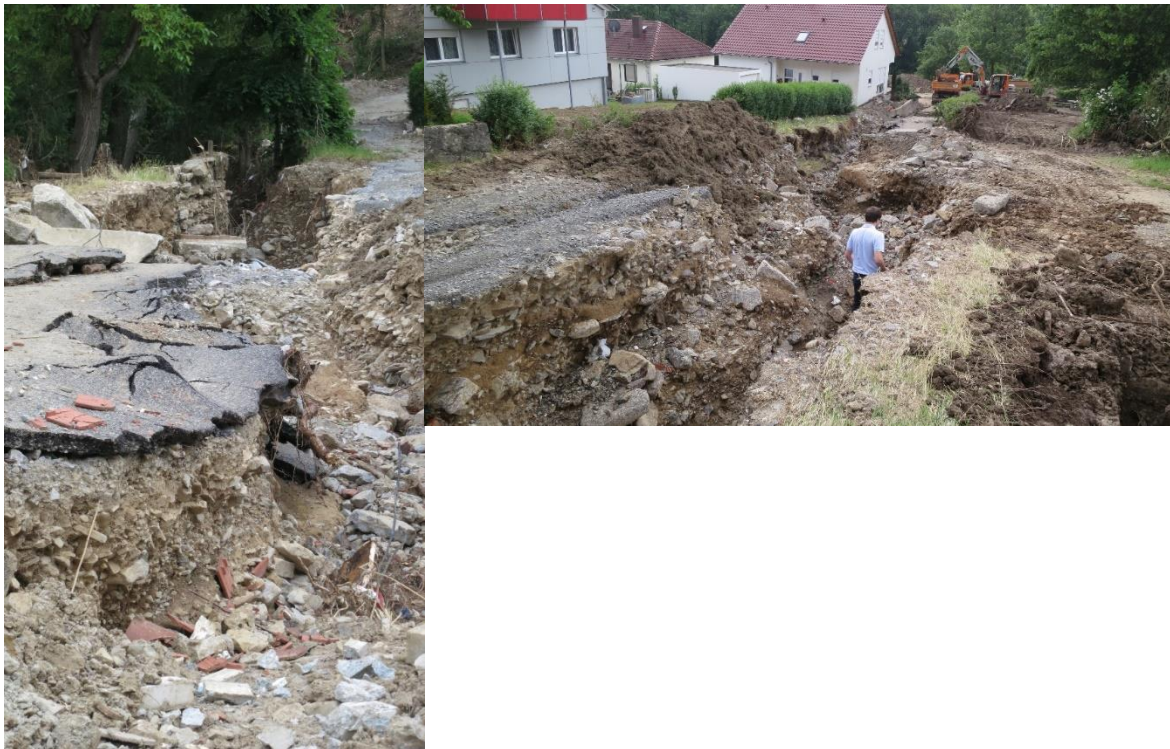
A similar scouring action was observed in Forchtenberg similar to that of Braunsbach. In both cases, there has been a blockade of passages due to debris and sediment accumulation from the upper catchment area. The thereby impounding water volume broke away abruptly when there was sufficient water pressure and caused a tidal wave that flowed along the valley line. In the area of the community Forchtenberg such a flood wave has created a main valley with a maximum depth of 3.5 m and a width at the bottom of approximately 1.5 m. Fortunately, there were no houses in the direct vicinity with a 3.5m by 1.5m chasm created as water rushed down a creek alongside an engineered 50cm pipe intended for creek flow. Some minor damage to buildings alongside the creek occurred on the bottom floor. One house had damage to the roof from debris action (probably a dragged-off tree trunk) upstream.

Figure 19: High water caused erosion along an asphalted road at the border of Forchtenberg.
